EXERCISE DESERT ROCK LAS VEGAS NV

EXERCISE DESERT ROCK V. JANUARY-JUNE 1953. VOLUME I. OPERATIONS--ETC(U)

Exercise Desert Rock V

Volume I - Operations

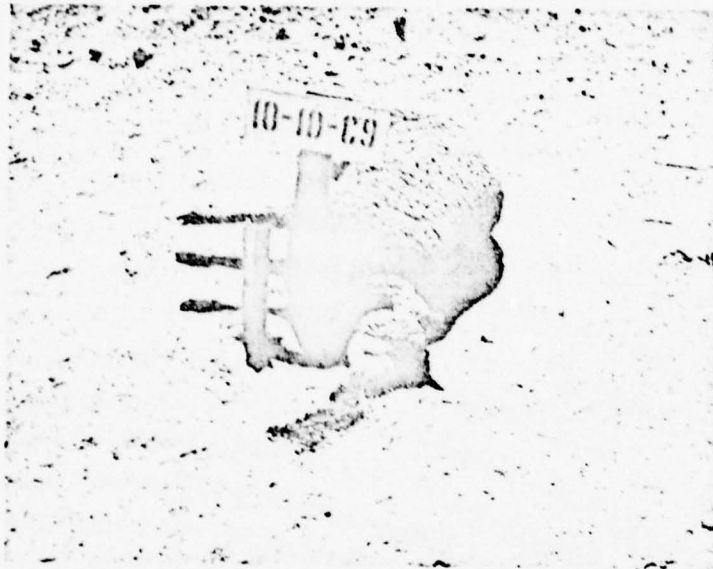
The sheep at 1000 yards from ground zero in position C-9 died from strangulation although it was severely burned. It acquired a radiation dosage of 3,715 and would have died eventually from the blast effects combined with acute lethal radiation sickness. The sheep in position C-5 had a broken right front leg during the blast due to the fact that the leg became entangled in the tether chain. This animal was destroyed to prevent further suffering. It received a radiation dosage of 96 r and would have in all probability survived the effects of the detonation. The sheep in positions C-1, C-2, C-3, C-6 and C-7 showed no visible effects from the blast but they acquired the following radiation dosages: C-1 3,610 r, C-2 2,760 r, C-3 1,985 r, C-6 1,140 r and C-7 1,965 r. These animals would all eventually die from acute lethal radiation sickness due to the large number of roentgens absorbed by them.

C-9 at 1000 yards. Se-  
verely burned but  
killed by strangula-  
tion. Received 3,715  
r.

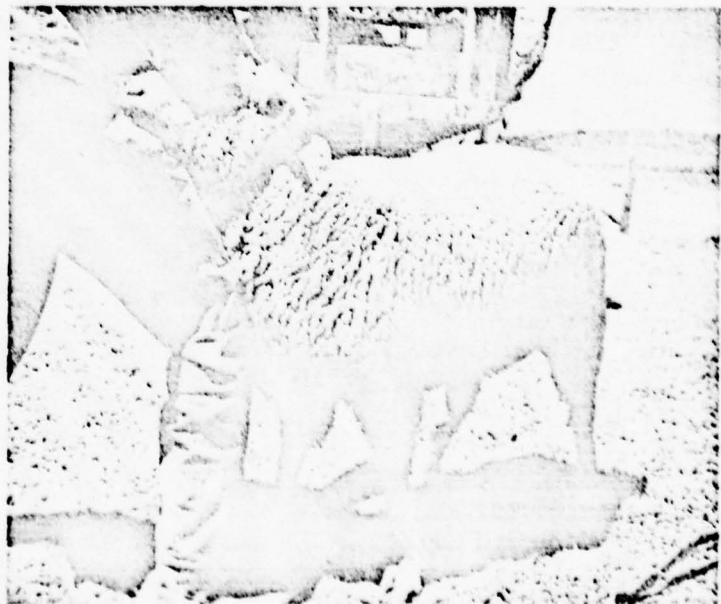
C-4 at 1500 yards. This  
sheep received slight  
wool burns over the left  
shoulder region and will  
survive the effects of  
the detonation. Received  
61 r.

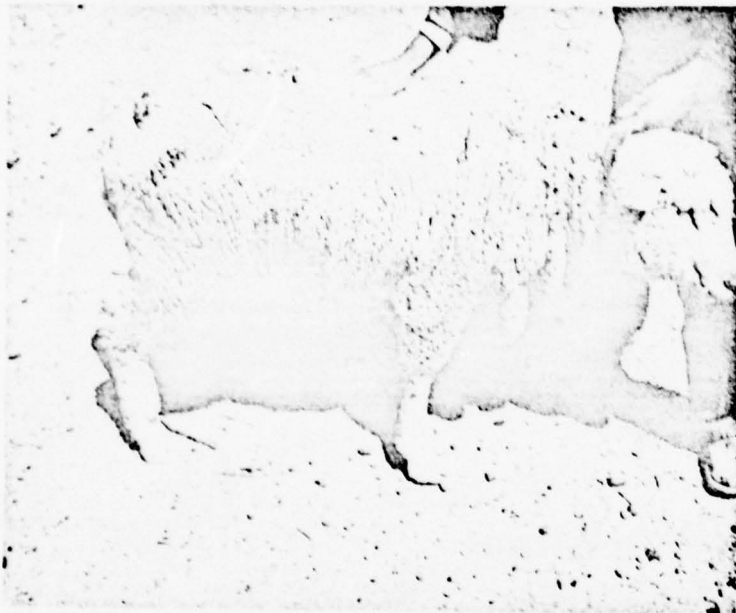
C-7 at 1500 yards. This animal acquired slight wool burns over the head and back and will survive. Received 158 r.

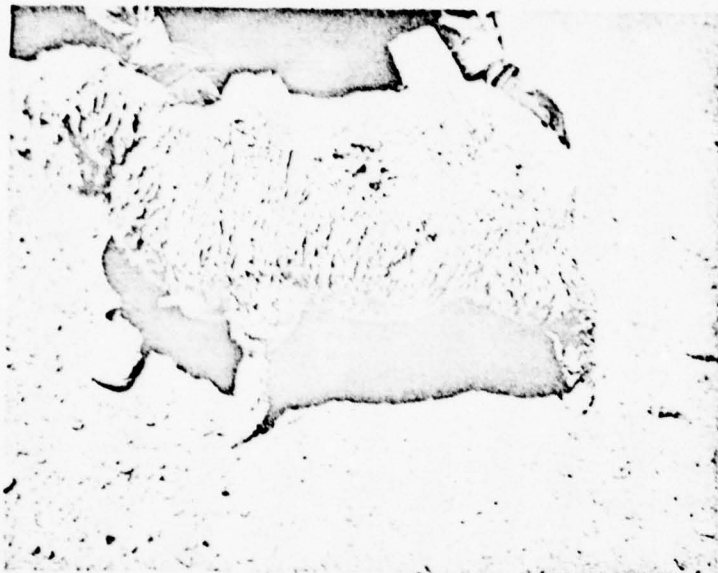
C-5 at 2000 yards. This animal received slight wool burns over the sides and back and will survive. Received 10 r.

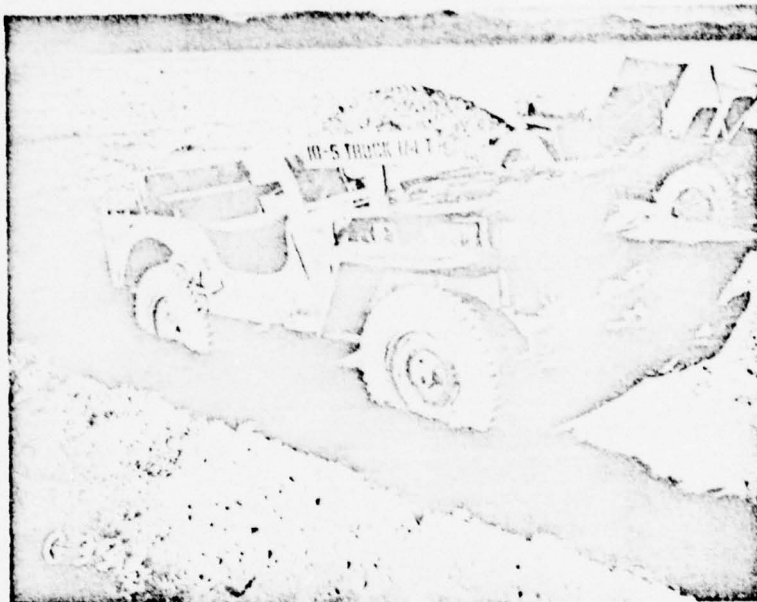
BEFORE

Truck 1/4 ton 4 x 4  
M-38 facing 45 de-  
grees right of GZ  
at 500 yards.

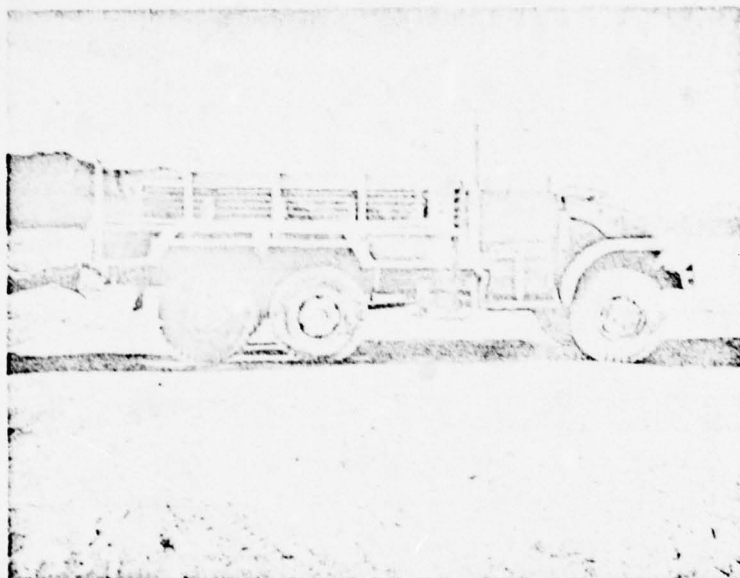
BEFORE

Truck, 2 1/2 ton 6 x 6  
GMC, M-135 at 500  
yards with right  
side toward GZ.

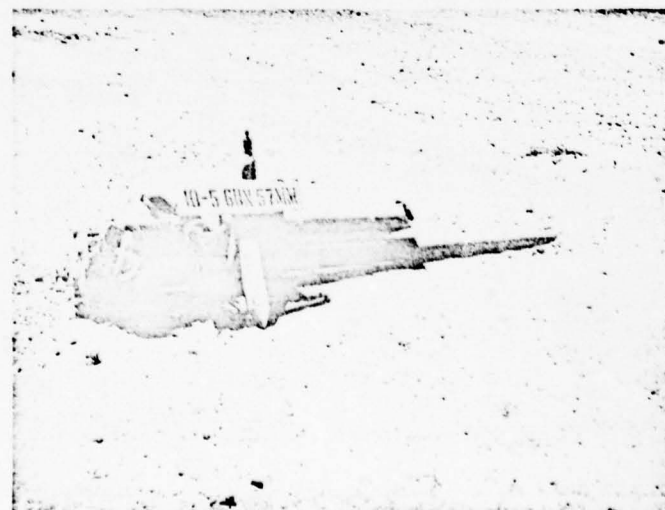
AFTER

Completely destroyed.  
Breech and tube torn  
completely loose from  
carriage. Some parts  
laying at 800 yard  
line.

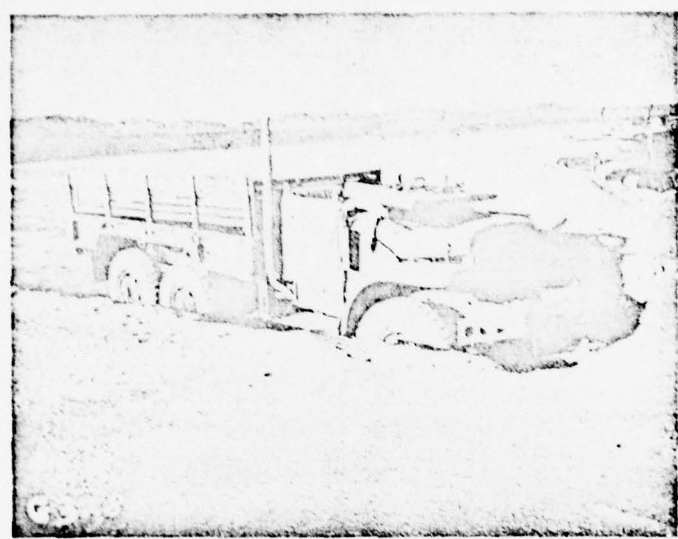
BEFORE

Truck, 2½ ton 6 x 6  
GMC M-135 facing GZ.  
at 500 yards.

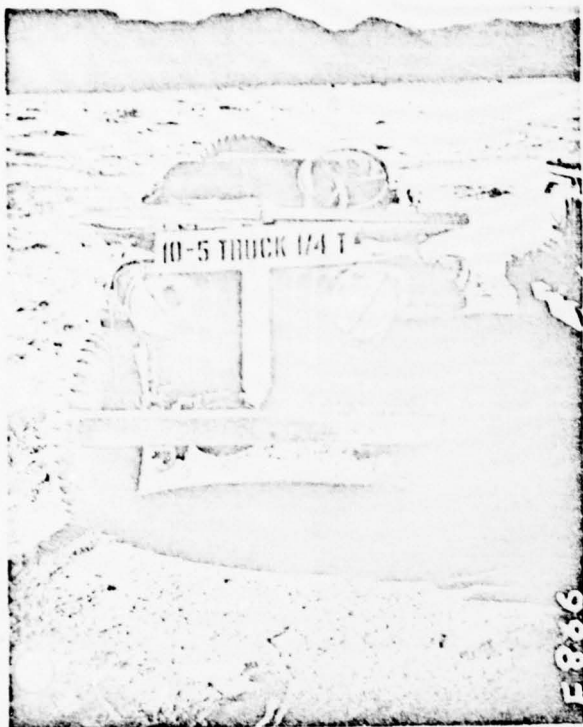
BEFORE

Truck, 1/4 ton 4 x 4, M-38  
facing GZ at 500 yards.
